Inspection carried out on 2nd May by Chris Bathory, accompanied by John Poynton (Site Manager's assistant). Overall impressions were good with one or two improvements and a couple of surprising unacceptable issues - as detailed. John, where possible, undertook actions to make improvements immediately - although Don Gaudoin (Site Director) will need to take proper responsibility to see that all actions are completed ASAP.

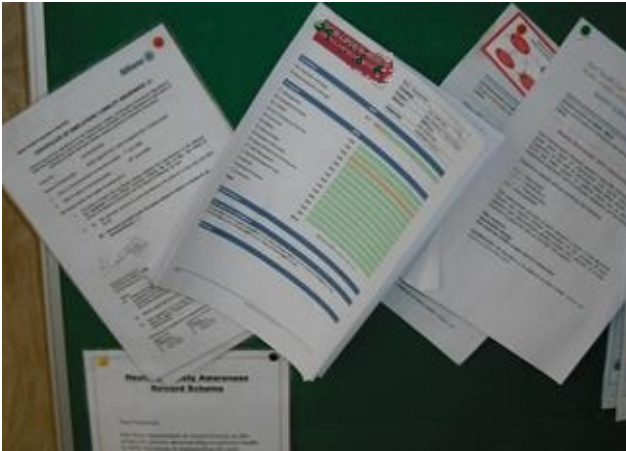
Use of suggestion box at site entrance, with related newsletter content added to noticeboard in canteen - also note latest site audit (ActiveSHE) report pinned onto noticeboard!

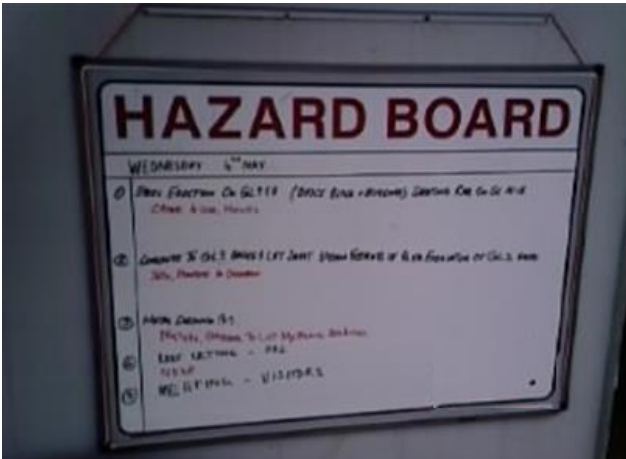
Hazard white board

Active use of 'Hazard white board' at site gate entrance to show current hazards.

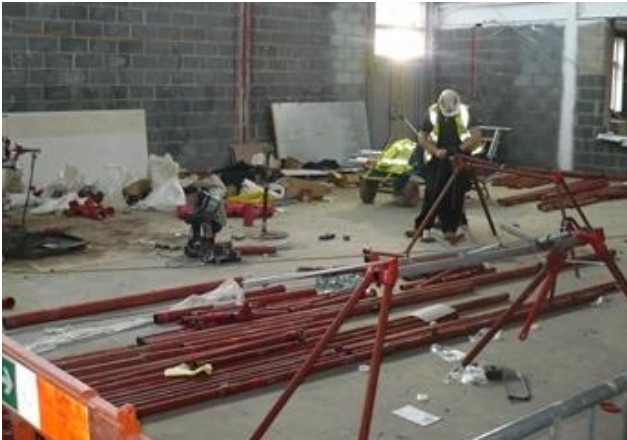
subcontract supervision inadequate

Unacceptable

Site to discuss competent supervision with both Contractor and sub contractor; it was felt during this and previous visits that the sprinkler installation contractor needed stronger management / supervision and this was underlined today with poor control of work area and incorrect selection of work at height access equipment.

Site to discuss with contractor to ensure that competent supervision is available on site to control the remaining installation works either from contractor or their sub contractor

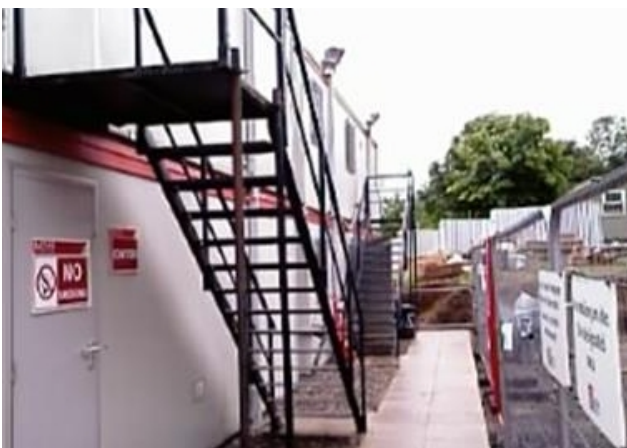
Site Cabin arrangement

A good set up on a small and confined site.

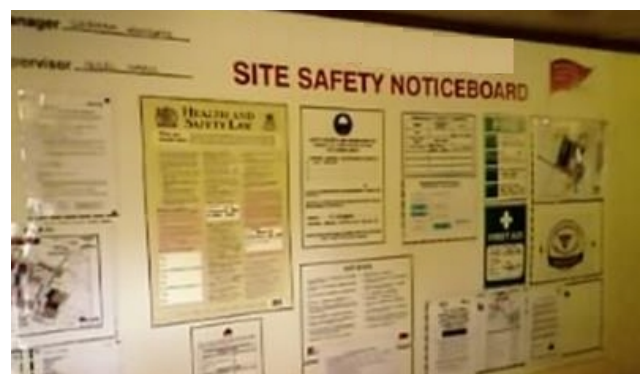
noticeboard 2

A good display of H&S posters on the site cabin information board.

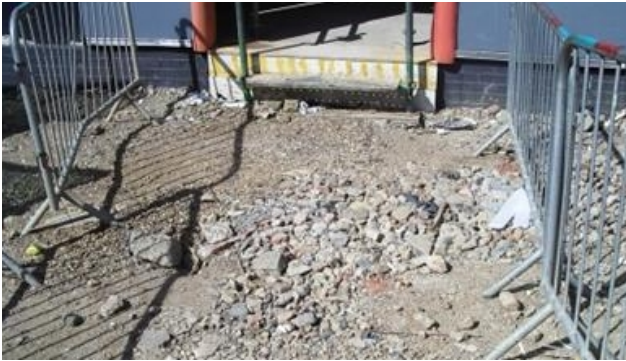
Rough filling for MEWP access

Improvement required

In-filling of very rough ground has been done by the doorway for MEWP access - however the rubble granulation size is much too large - MEWP will be unsteady when traversing over the area. Large lumps to be removed and replaced with a finer gravel/powder mix to give a smoother transition.

Action for Don Gaudoin by 31/05/2014

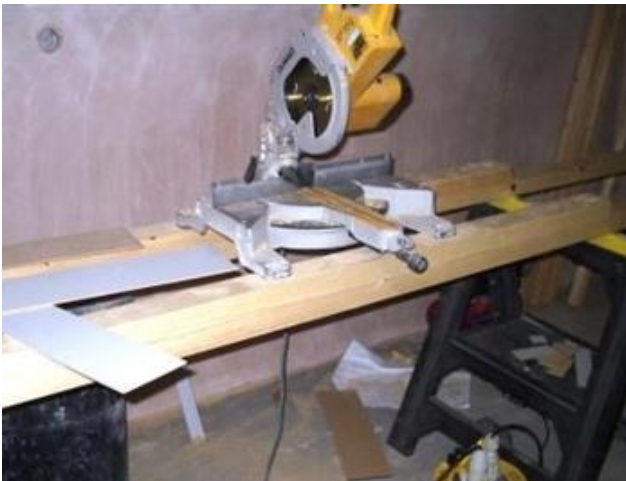
chop saw no extraction

Improvement required

No extraction provided on chop-saw. Only occasionally used, but this is in an enclosed area and extraction should be available.

Action for Don Gaudoin by 16/05/2014

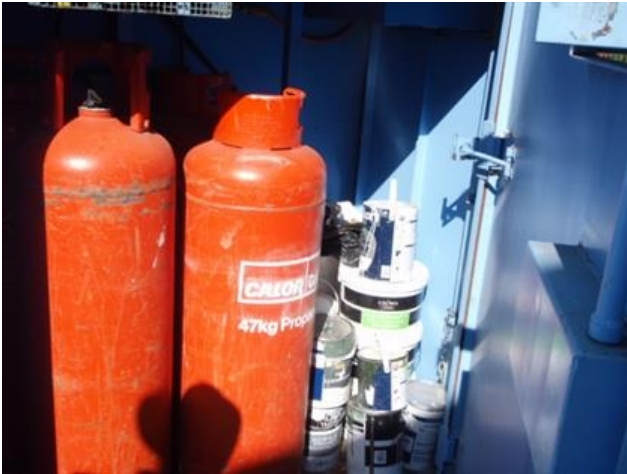
Gas and Flammable paint storage

Improvement required

Empty gas bottles should be returned promptly and flammable paints should be kept separate.

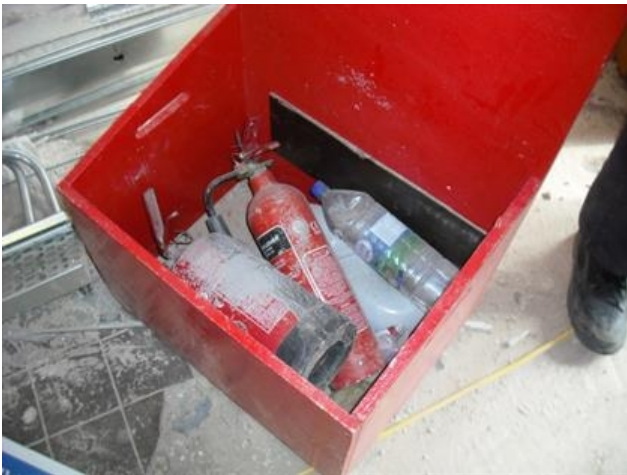
Fire equipment storage

Unacceptable

Scruffy Fire point on level2 by lift shaft. Fire points are NOT to be used as bins. Urgent team briefing to be delivered by Site Manager tomorrow morning. Clean up required ASAP.

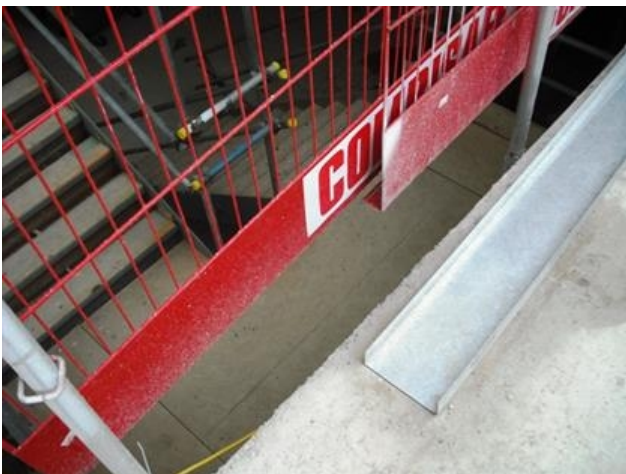
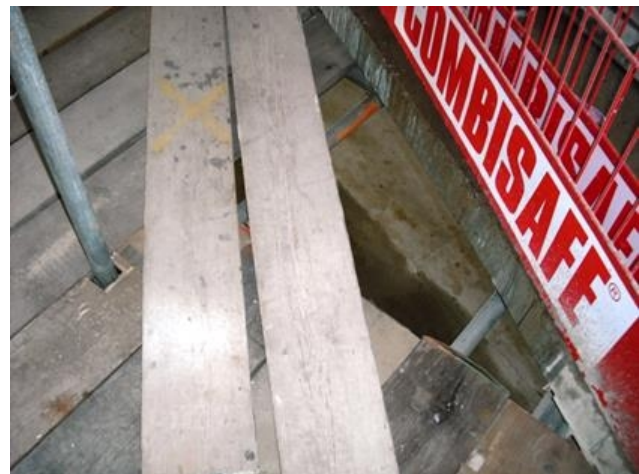
edge protection missing

edge protection missing 2

Unacceptable

The barriers being used to protect fall into service trench are unsuitable. Pedestrian barriers must NOT be used to prevent falls from height. The barrier must be replaced with a proprietary edge protection or tube and fitting.

Action for Don Gaudoin by 31/05/2014

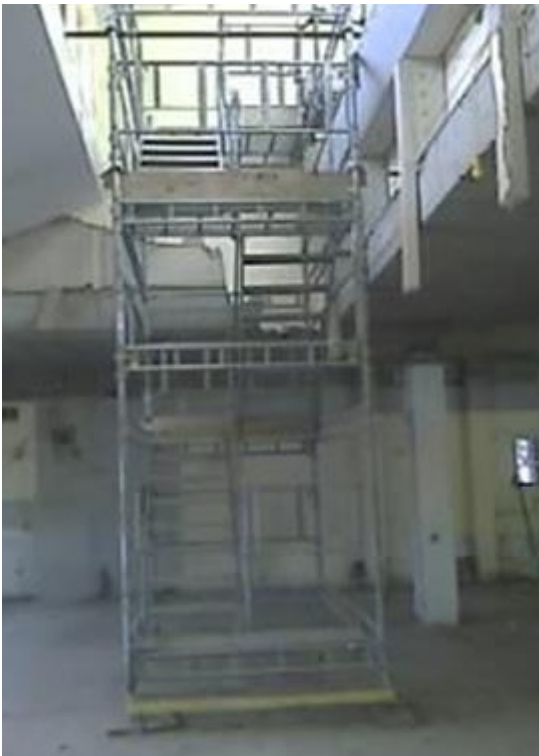
Correct and sensible use of gates on access routes around site, plus good deployment of Haki stairs for access.
